**Flood Control Project Maintenance
Levee Inspections**

Maintenance Issue Types Only, Levee Inspection Report By Mile - Spring 2018

Solano County Public Works Mellin Levee

Waterway	Bank	Unit Miles	Inspection Start/End	Inspector
Unit No. 01 Mellin Levee	Right	0.59	04/10/2018 04/10/2018	Keith Millard

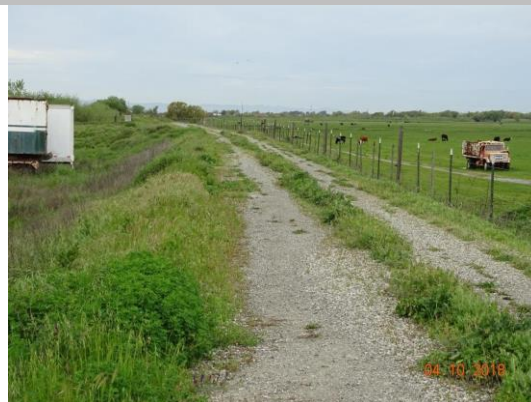
Photo 1 of 1 : SP_2018_NA0012_258_1_20180410_00008.jpg

LM Start	0.00	Rating **	U	Issue No.	1
LM End	0.28	Issue Type +	Ma	Location *	LS
Category	Earthen Levee			GPS Latitude/Longitude	
				Start	End
Item	Vegetation			38.174055°	38.176849°
				-121.674285°	-121.677842°
DWR ID	DWR_NA0012_01_f_2017_1				
Comment Code					
V1 : Control annual grass and weeds on the levee slopes and easements.					
Inspector Comment					
Unable to adequately see landside due to vegetation.

Landside vegetation should be managed to allow inspection of ground surface and access.
